# Let it be PLANNED!

## Avalanche-, Debris Flow- and Mudslide RADAR

DI Dr. techn. Koschuch Richard

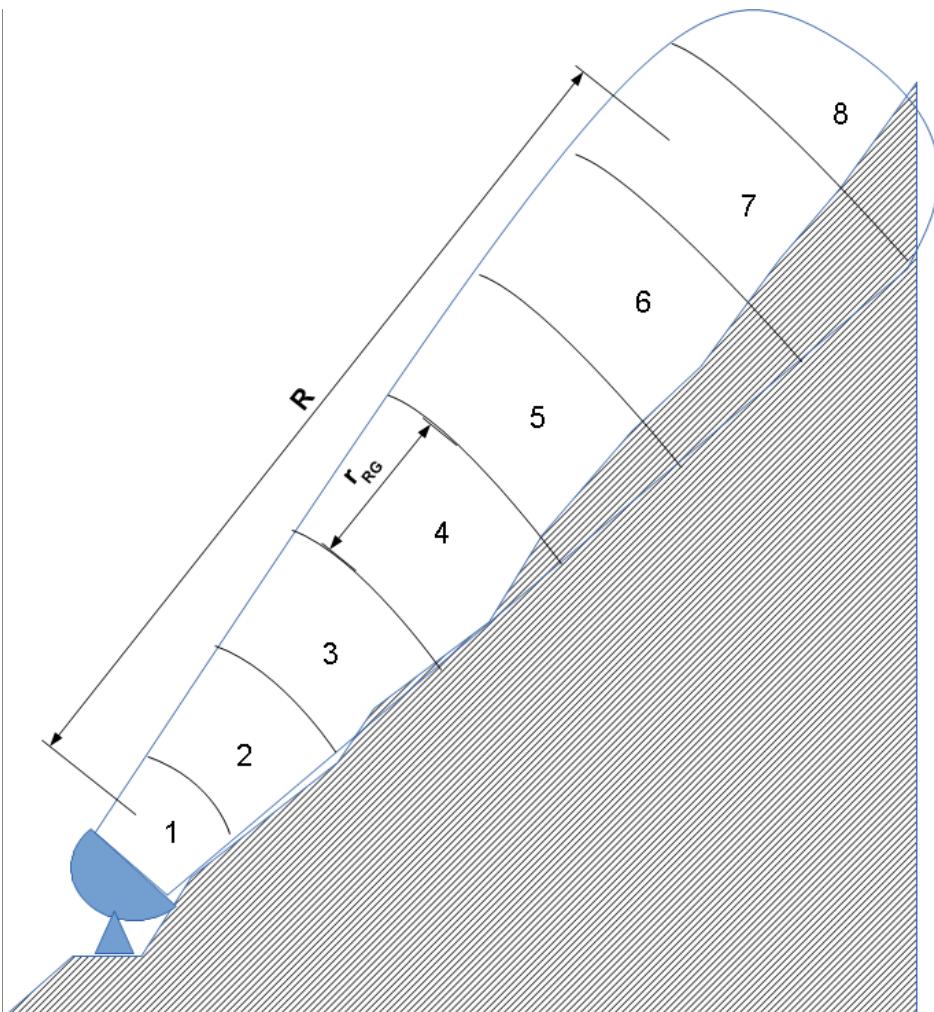
# Principle of the Radar

- The RADAR emits modulated pulses
- Max. measurement distance  $R=2,5$  km
- RG-length  $r_{RG}=15-250$  m
- Velocities up to 300 km/h are detected simultaneously in each RG
- If there is a hazardous event (fast moving objects), a alarming trigger is activated.

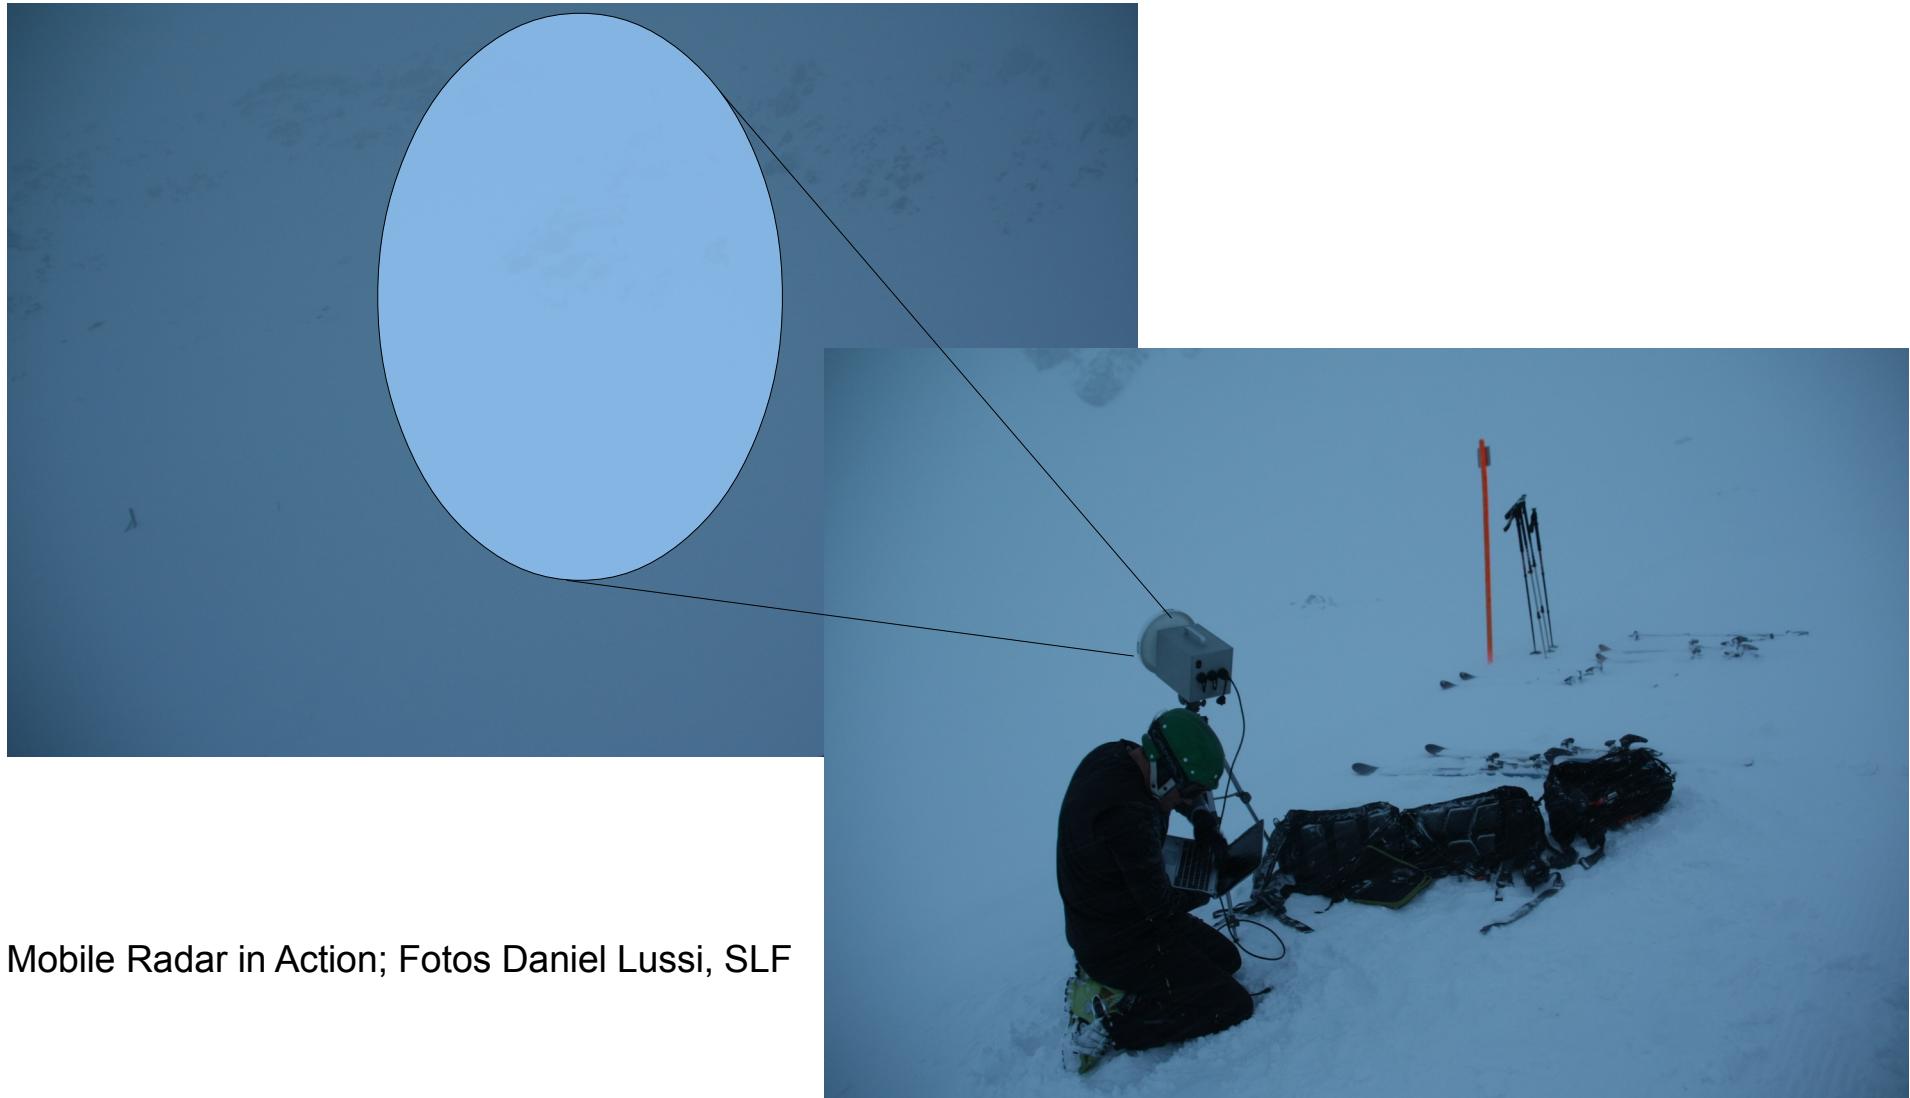
# Function I: Mobile RADAR

Mobile Radar in Action; Fotos Daniel Lussi, SLF

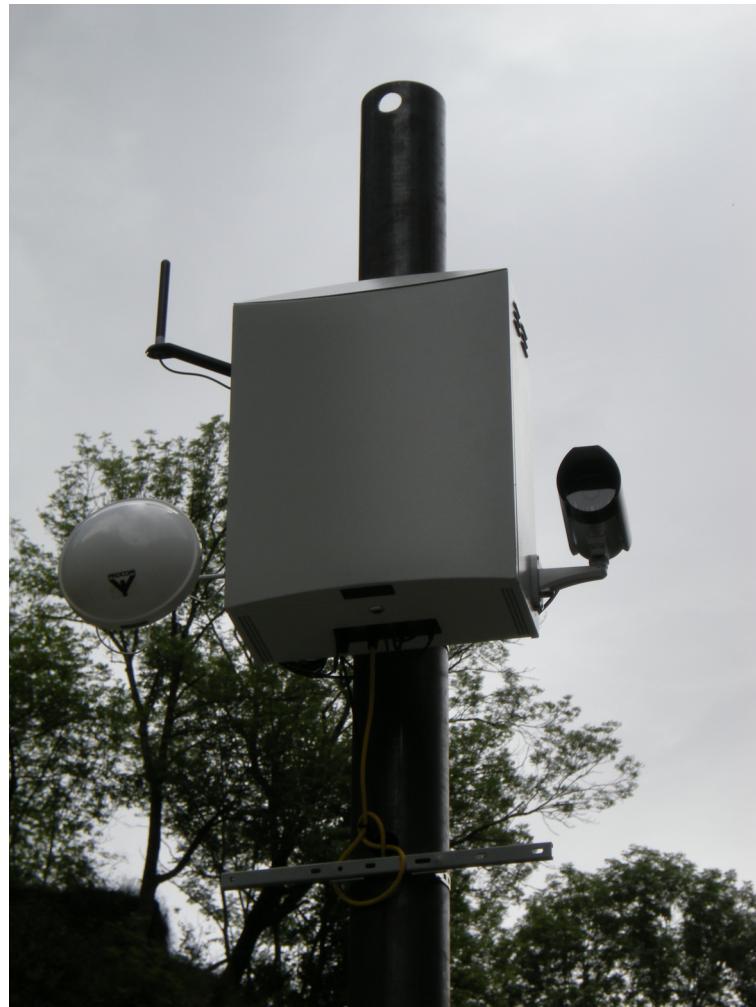
# Specification

Parameter	Quantity	Tolerance	Unit
Mode	Pulse/PCM		
Frequency	10,0-10,5		GHz
Power C.	40	<	W
Range	30-2500		m
Targetszie	1 0,25	min > at 2km min > at 1km	m <sup>2</sup>
Velocity	0,2-100	min/max	m/s
RG	128	max	
RG-length	15-250	min/max	m

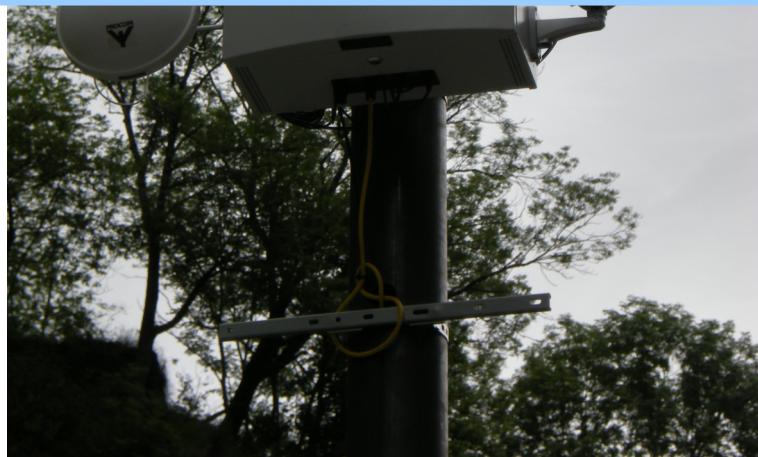
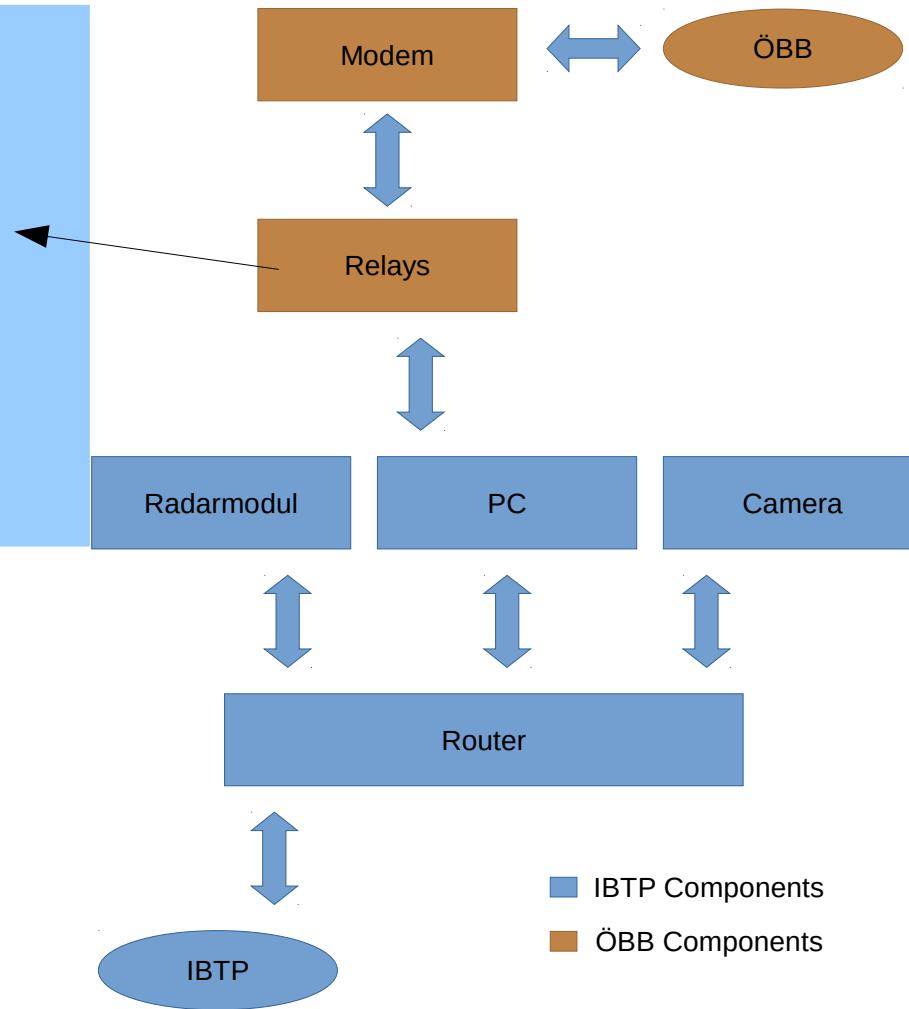
# Lattenbach ÖBB Project

## 4 Relays

- Radar OK
- Water Level
- Debris Flow Small Event
- Debris Flow Big Event

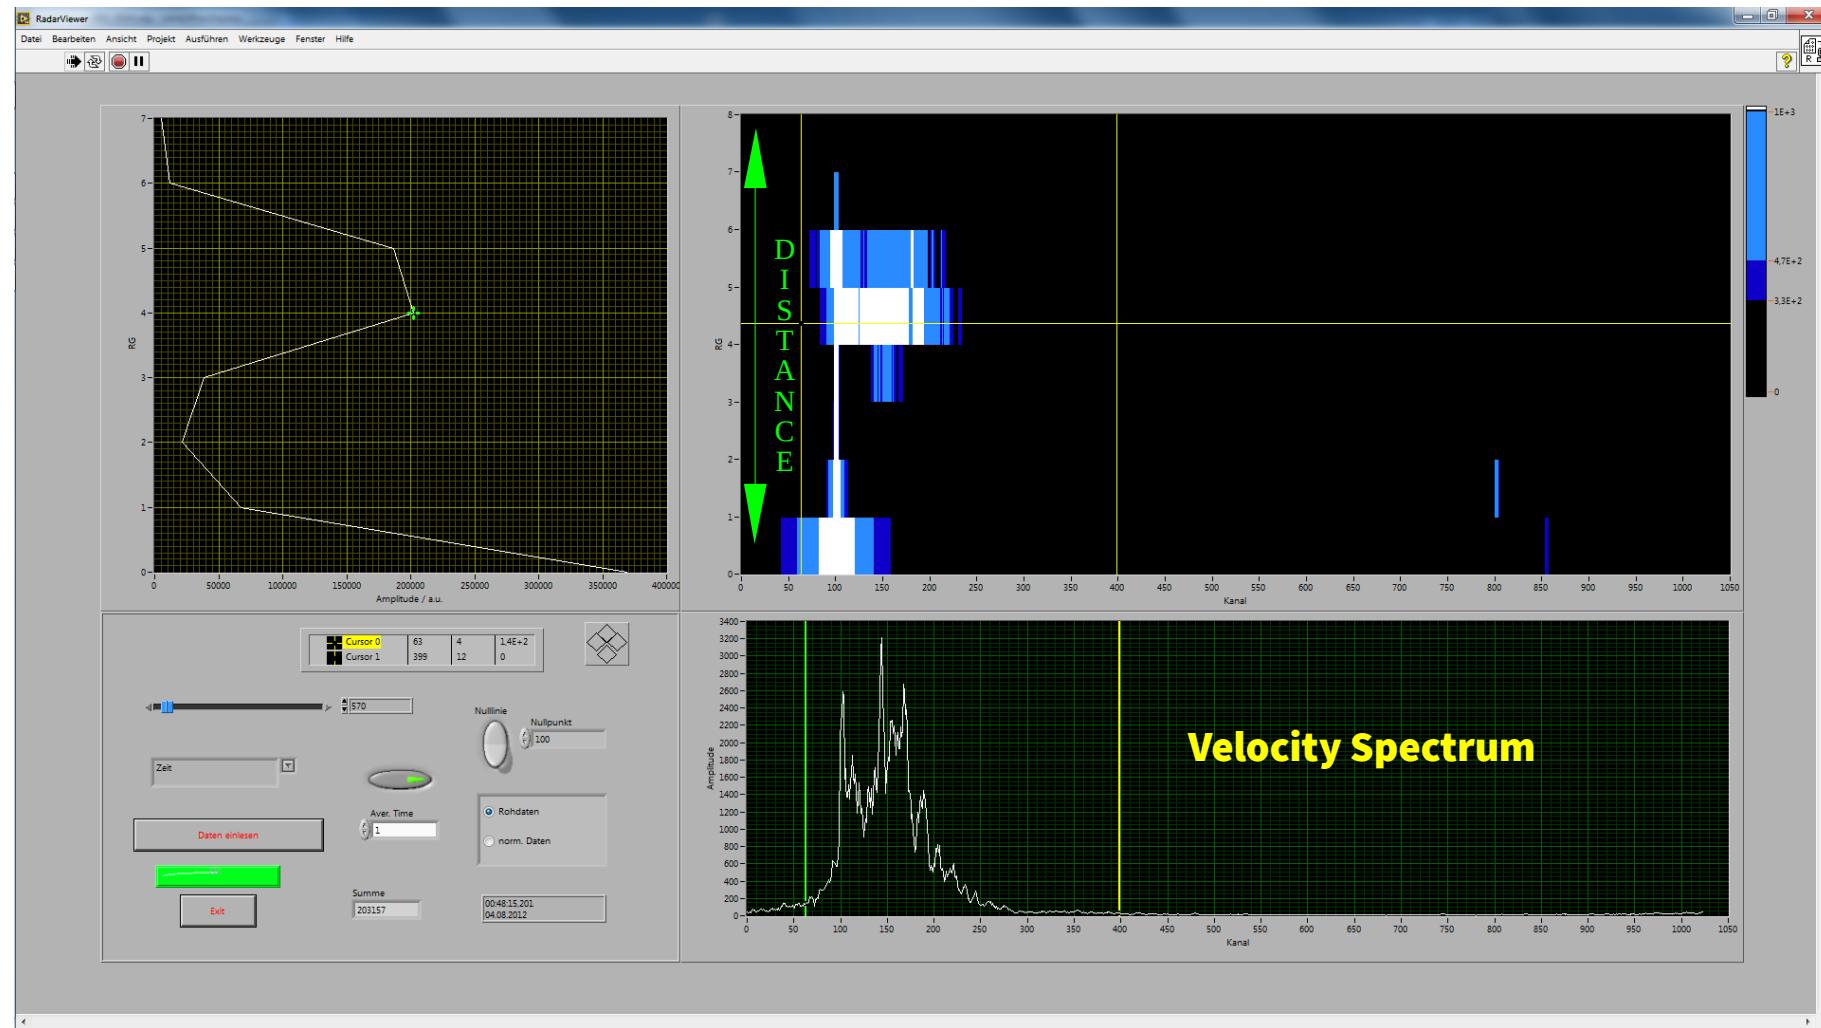
## Data Analysis 23-26.08.2012: Example Data Frame

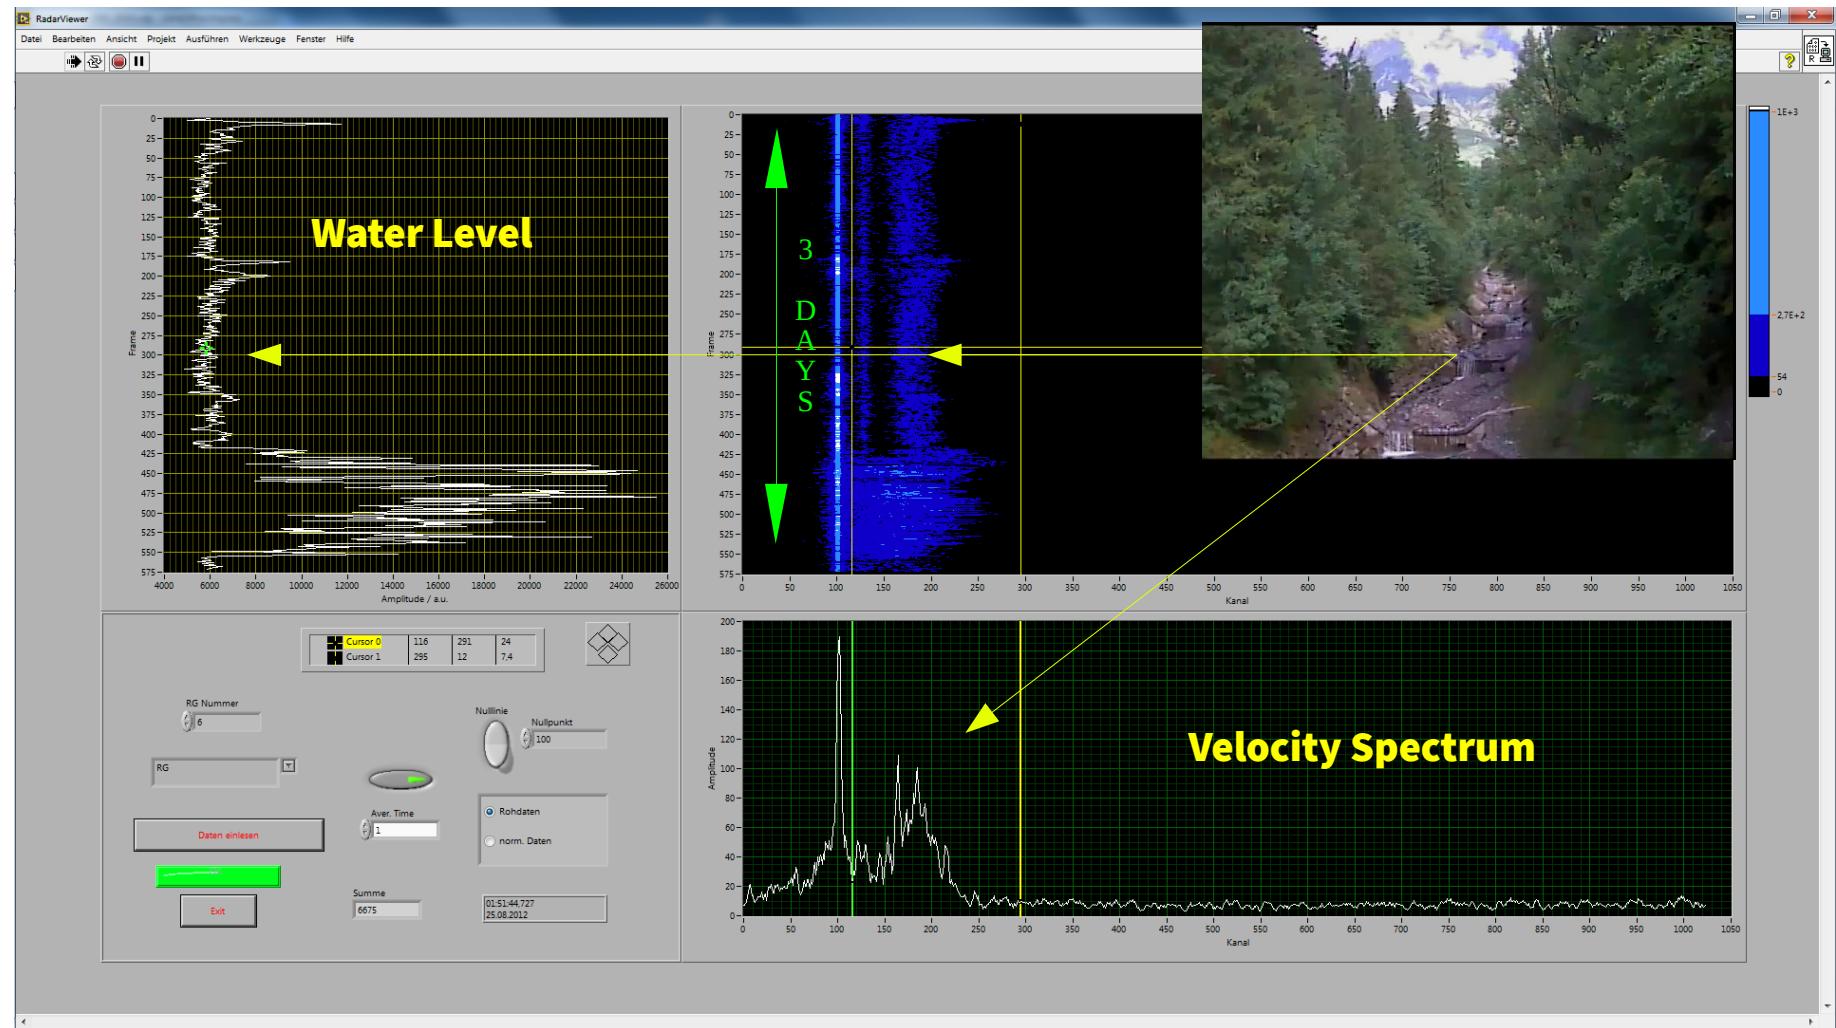
## Data Analysis 23-26.08.2012: RG 6 Low Water Level

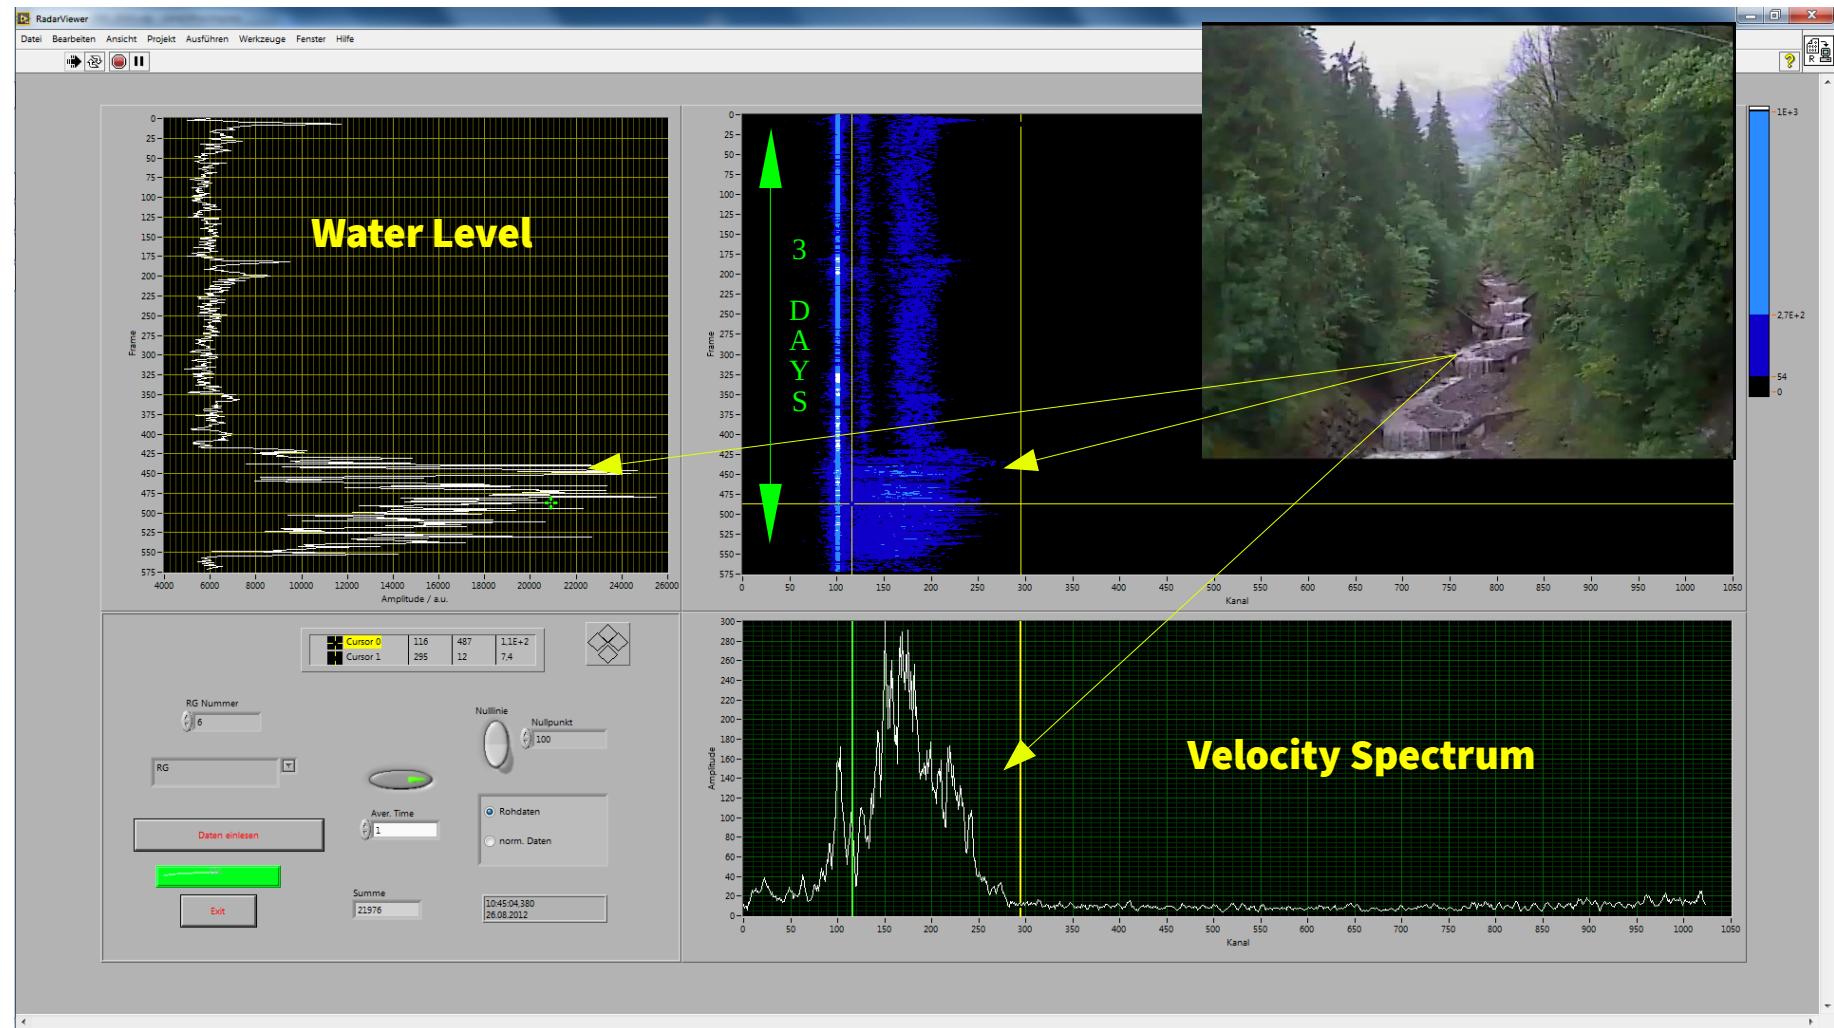
## Data Analysis 23-26.08.2012: RG 6 High Water Level → Alarm

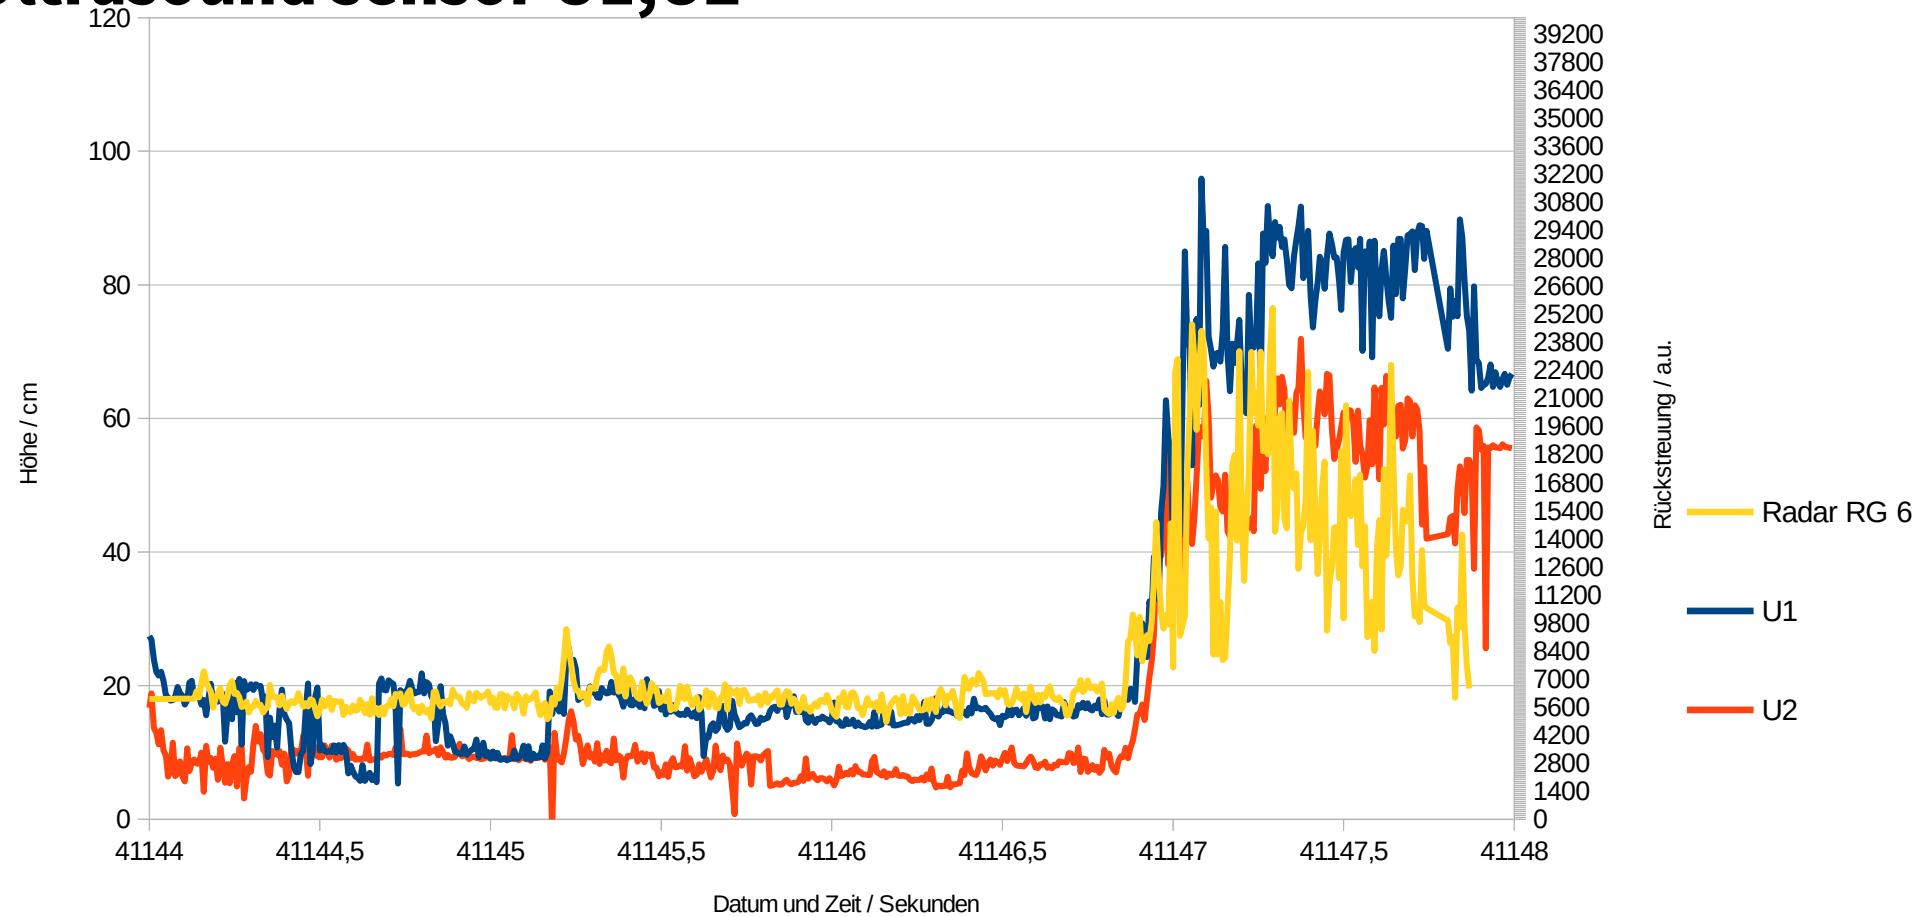
## Data Analysis 23-26.08.2012: Water Level Radar versus Ultrasound sensor U1;U2

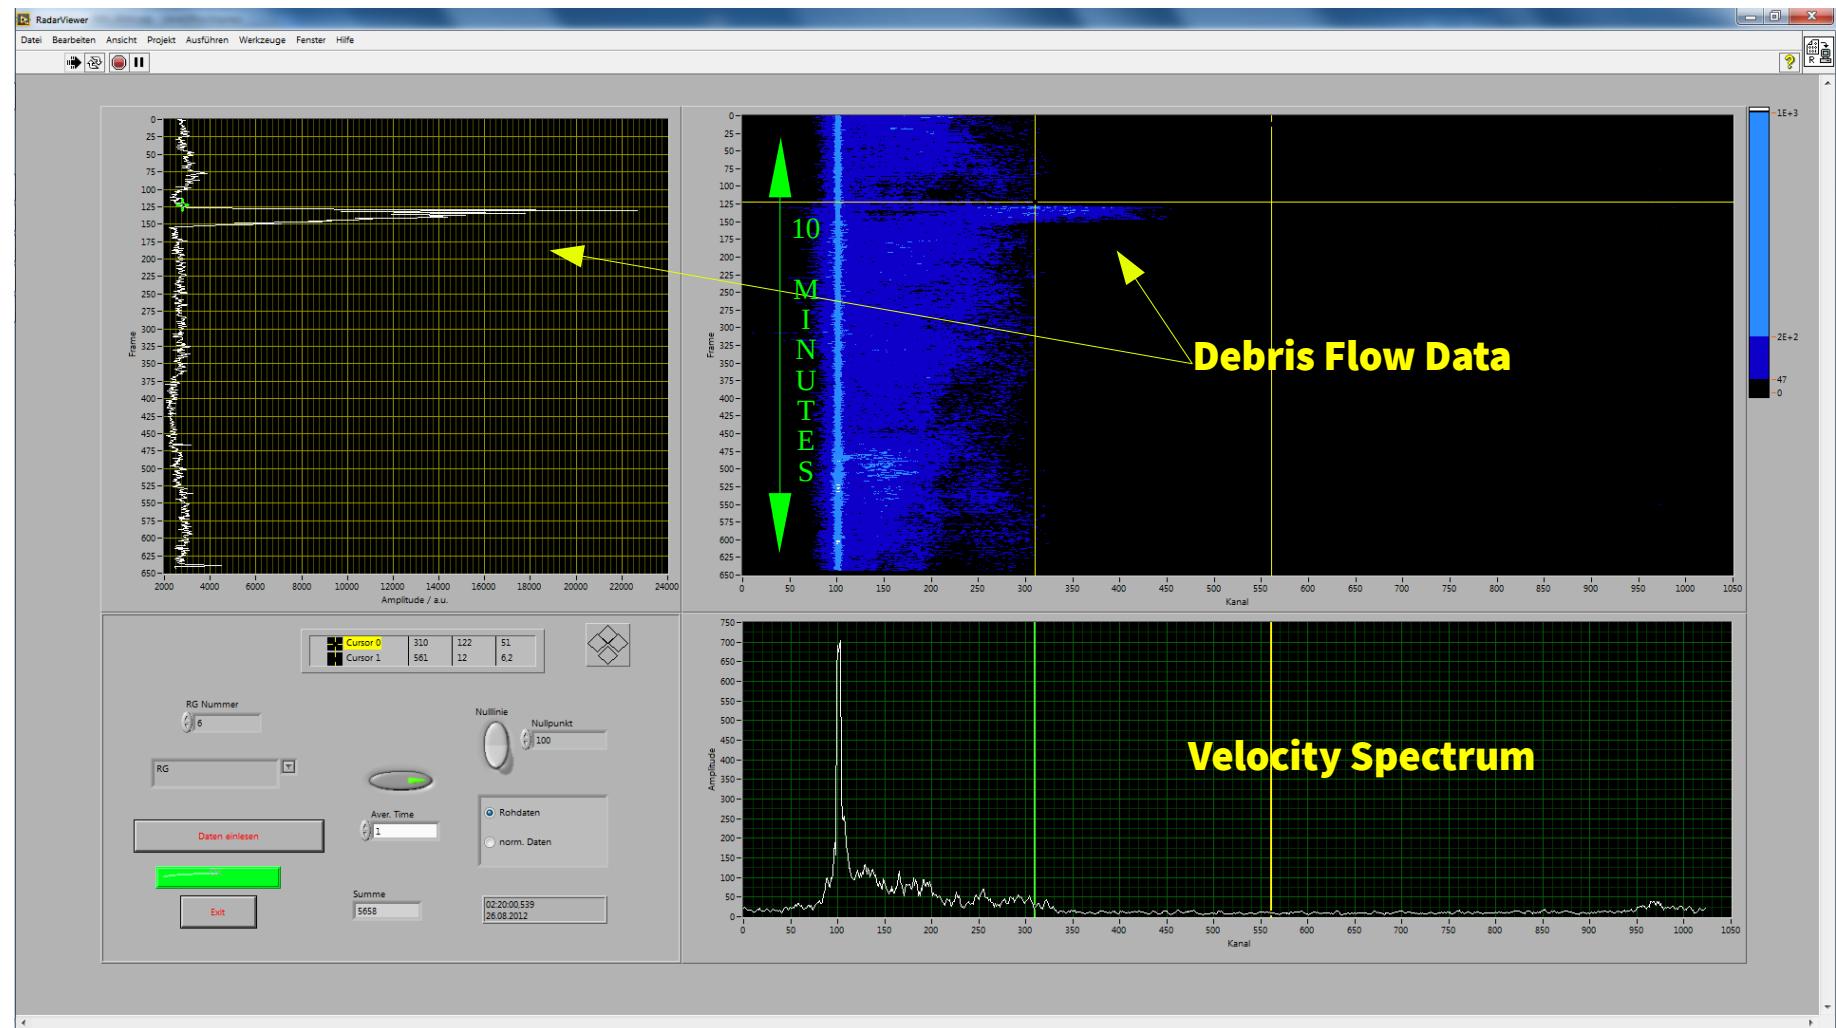
## Small Debris Flow Event from 26.08.2012 RG6

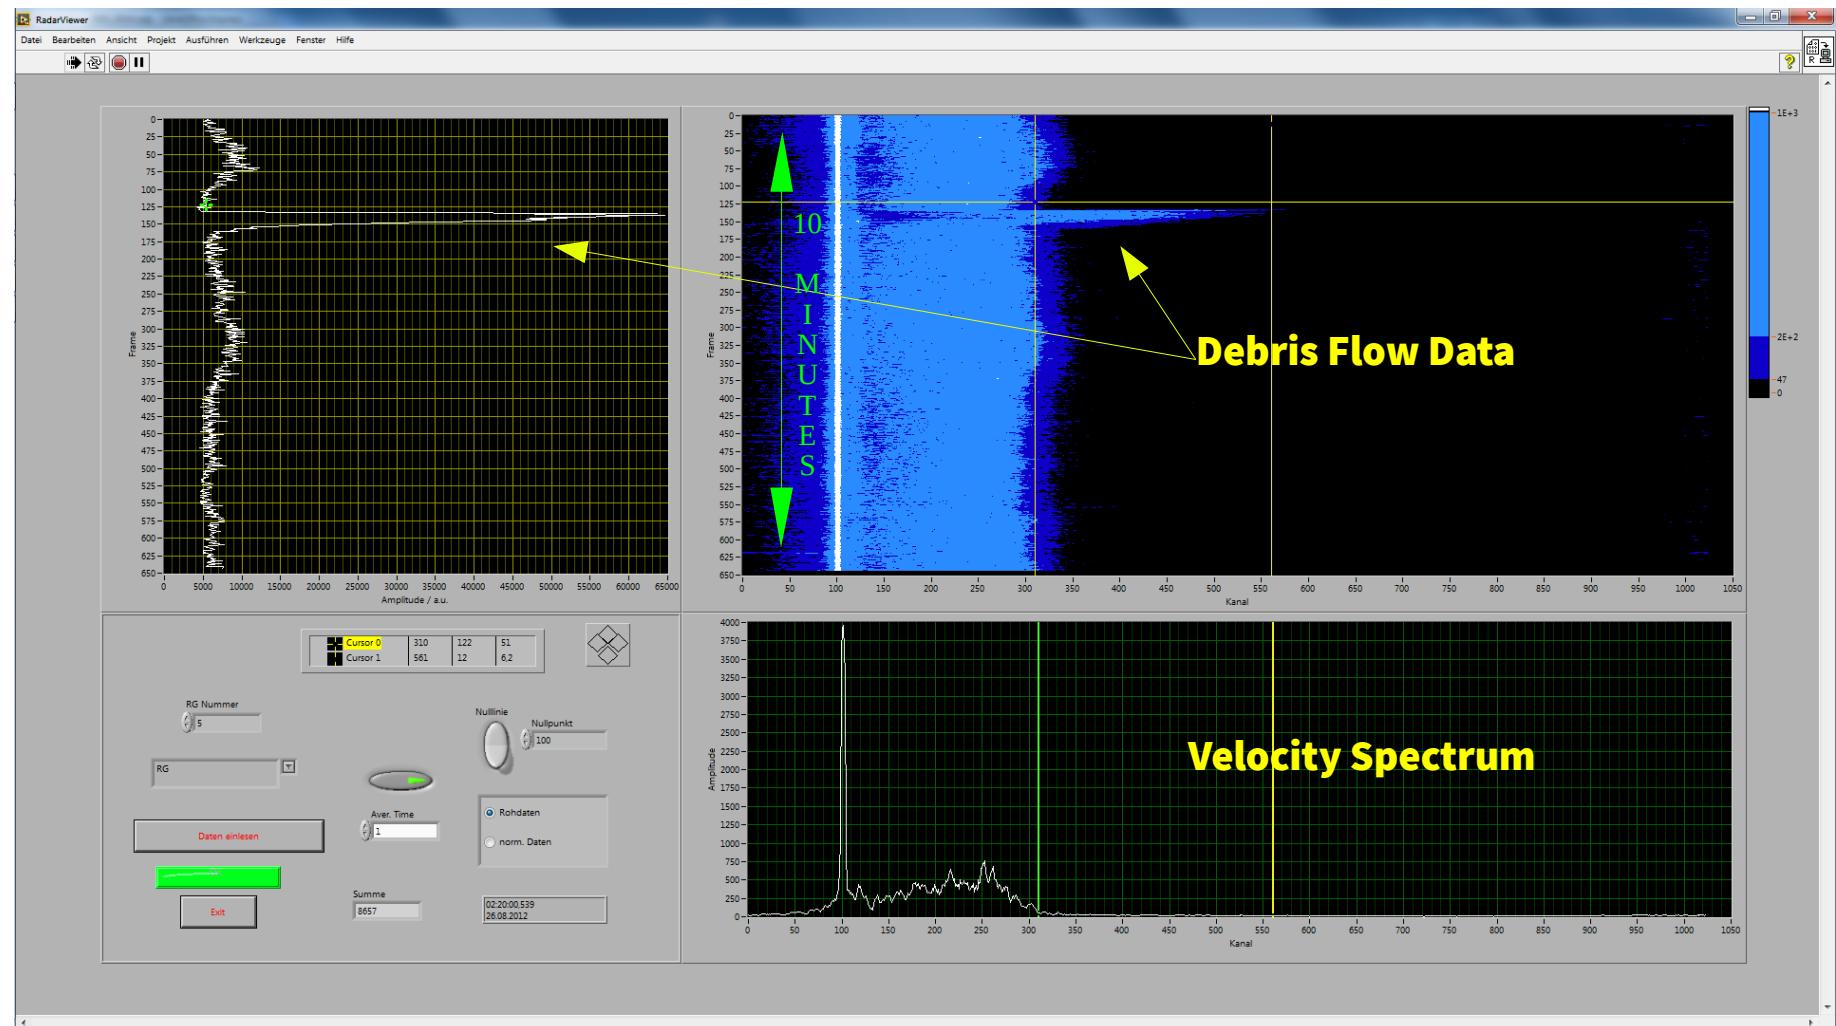
## Small Debris Flow Event from 26.08.2012 RG5

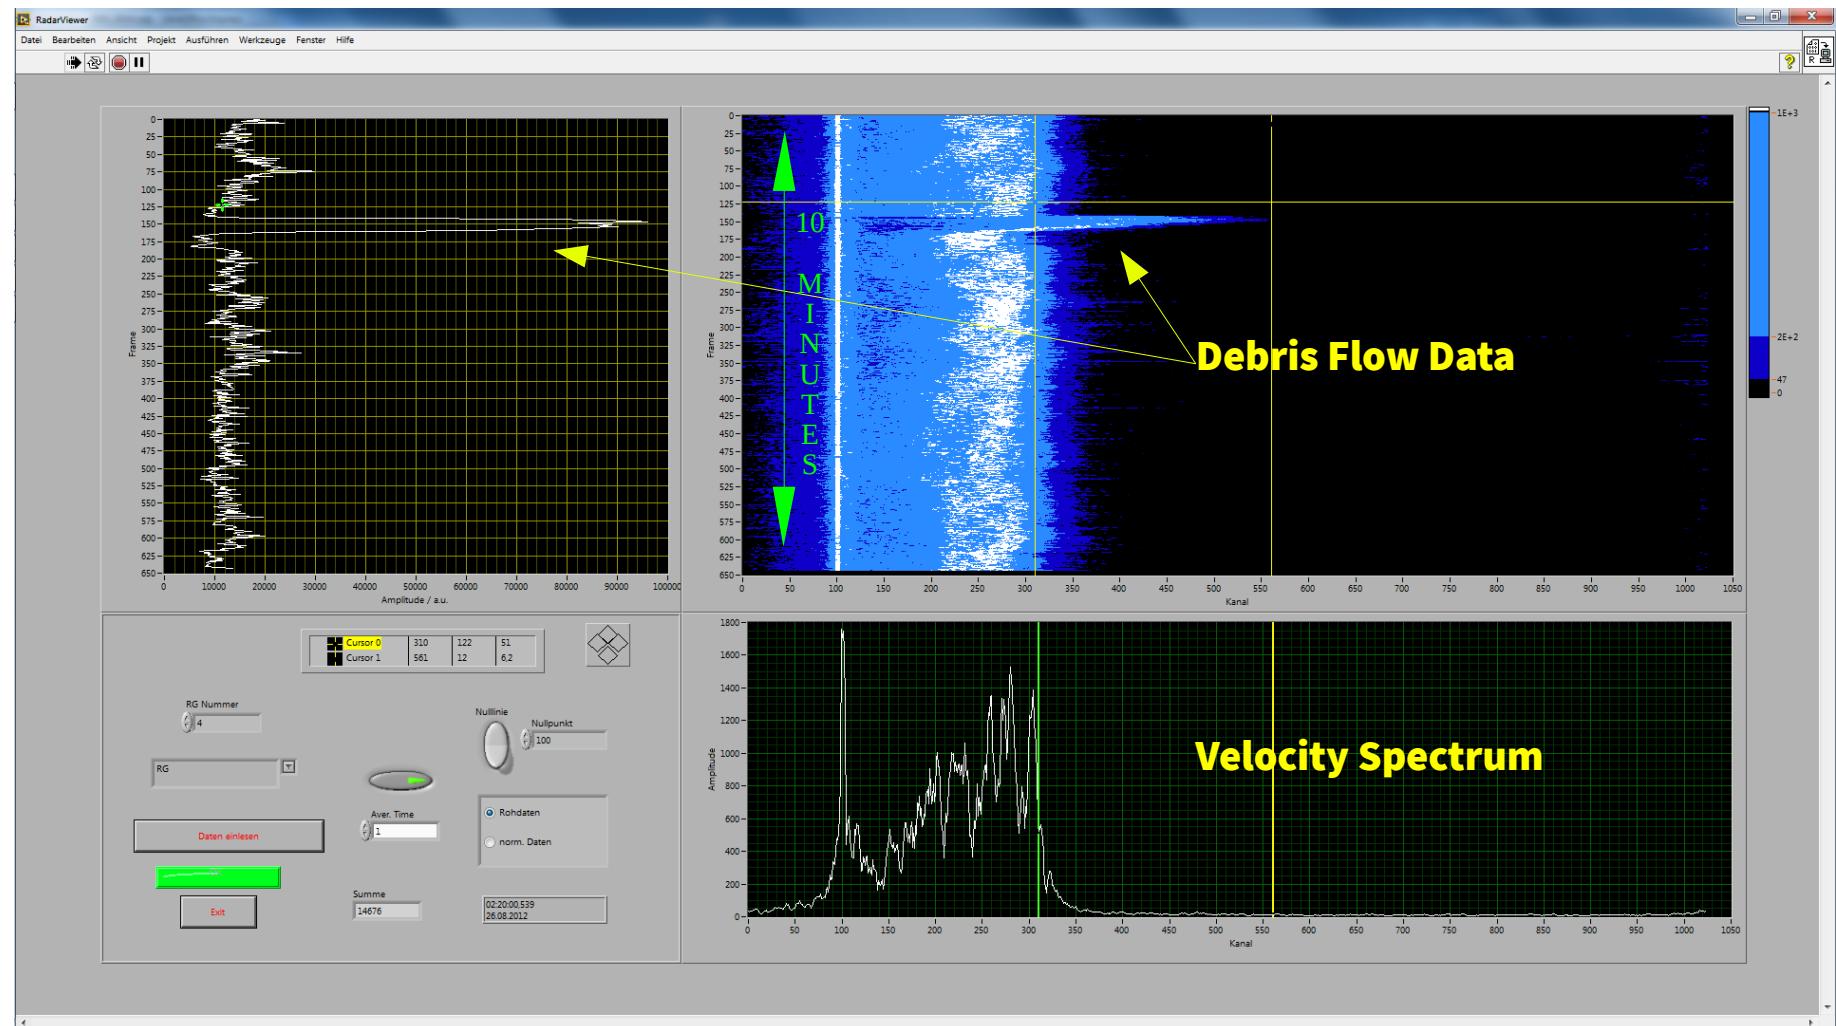
## Small Debris Flow Event from 26.08.2012 RG4

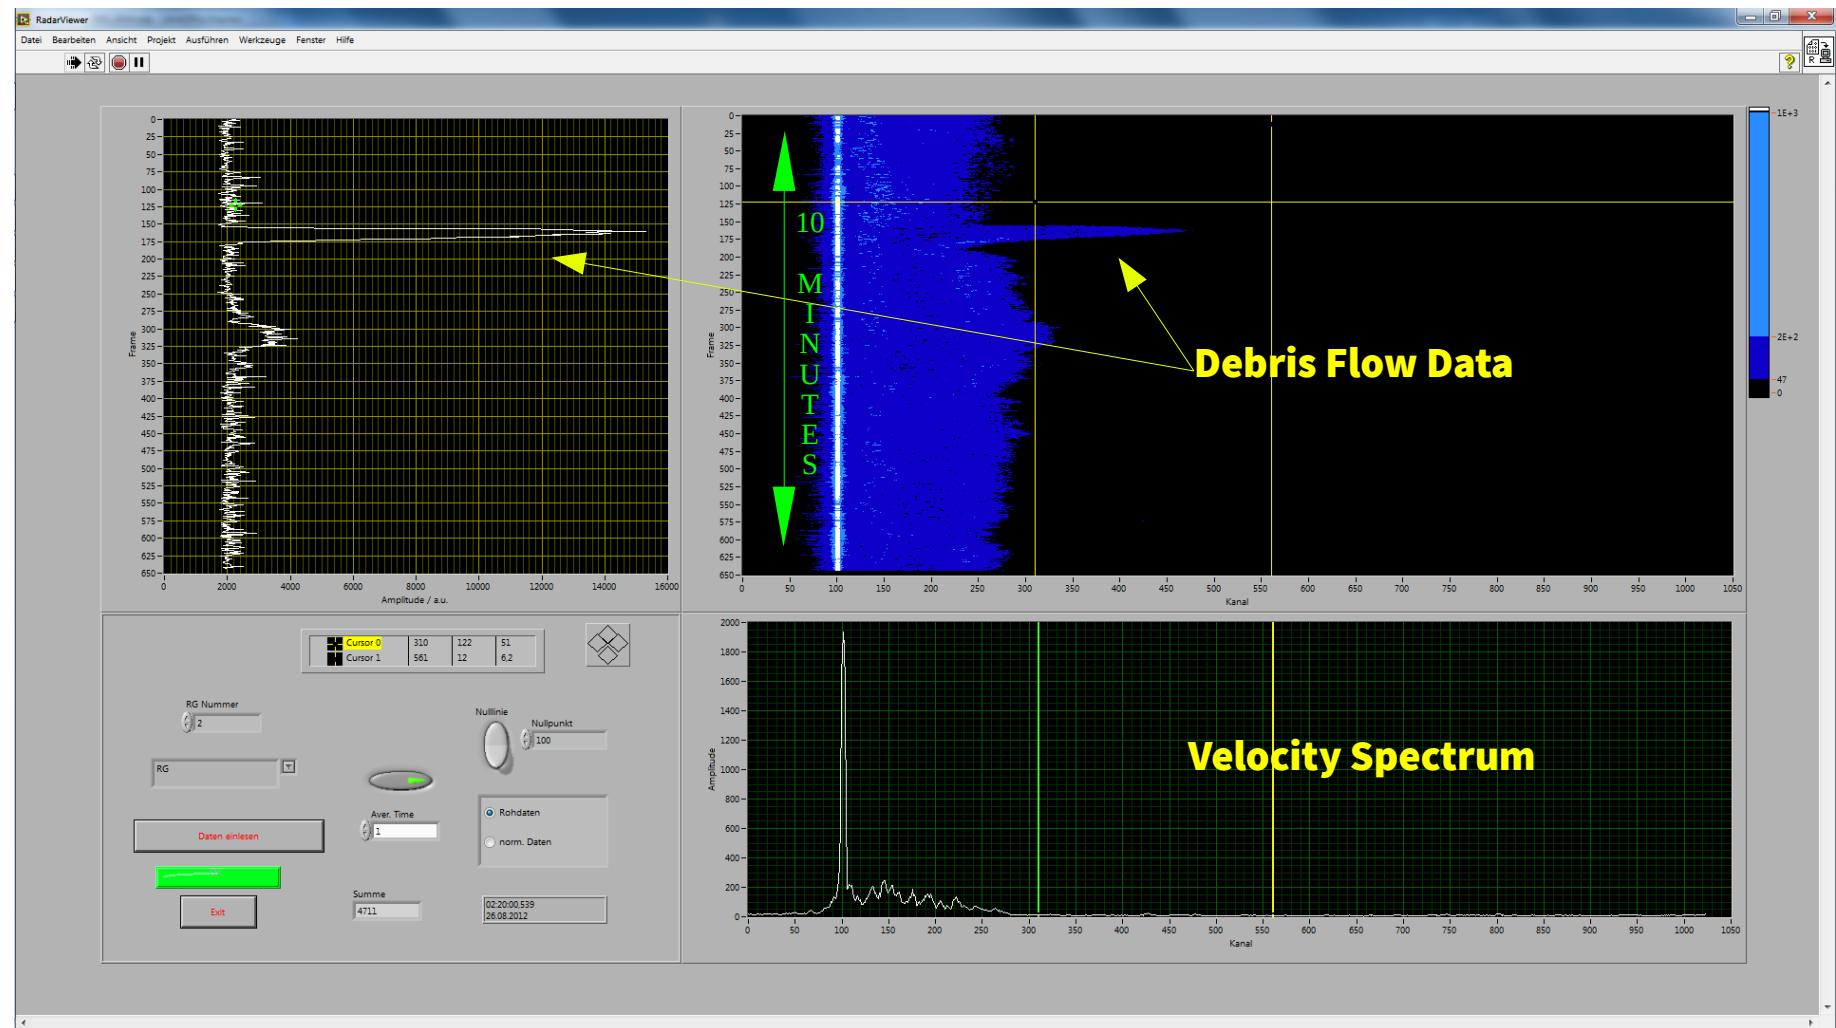
## Small Debris Flow Event from 26.08.2012 RG2

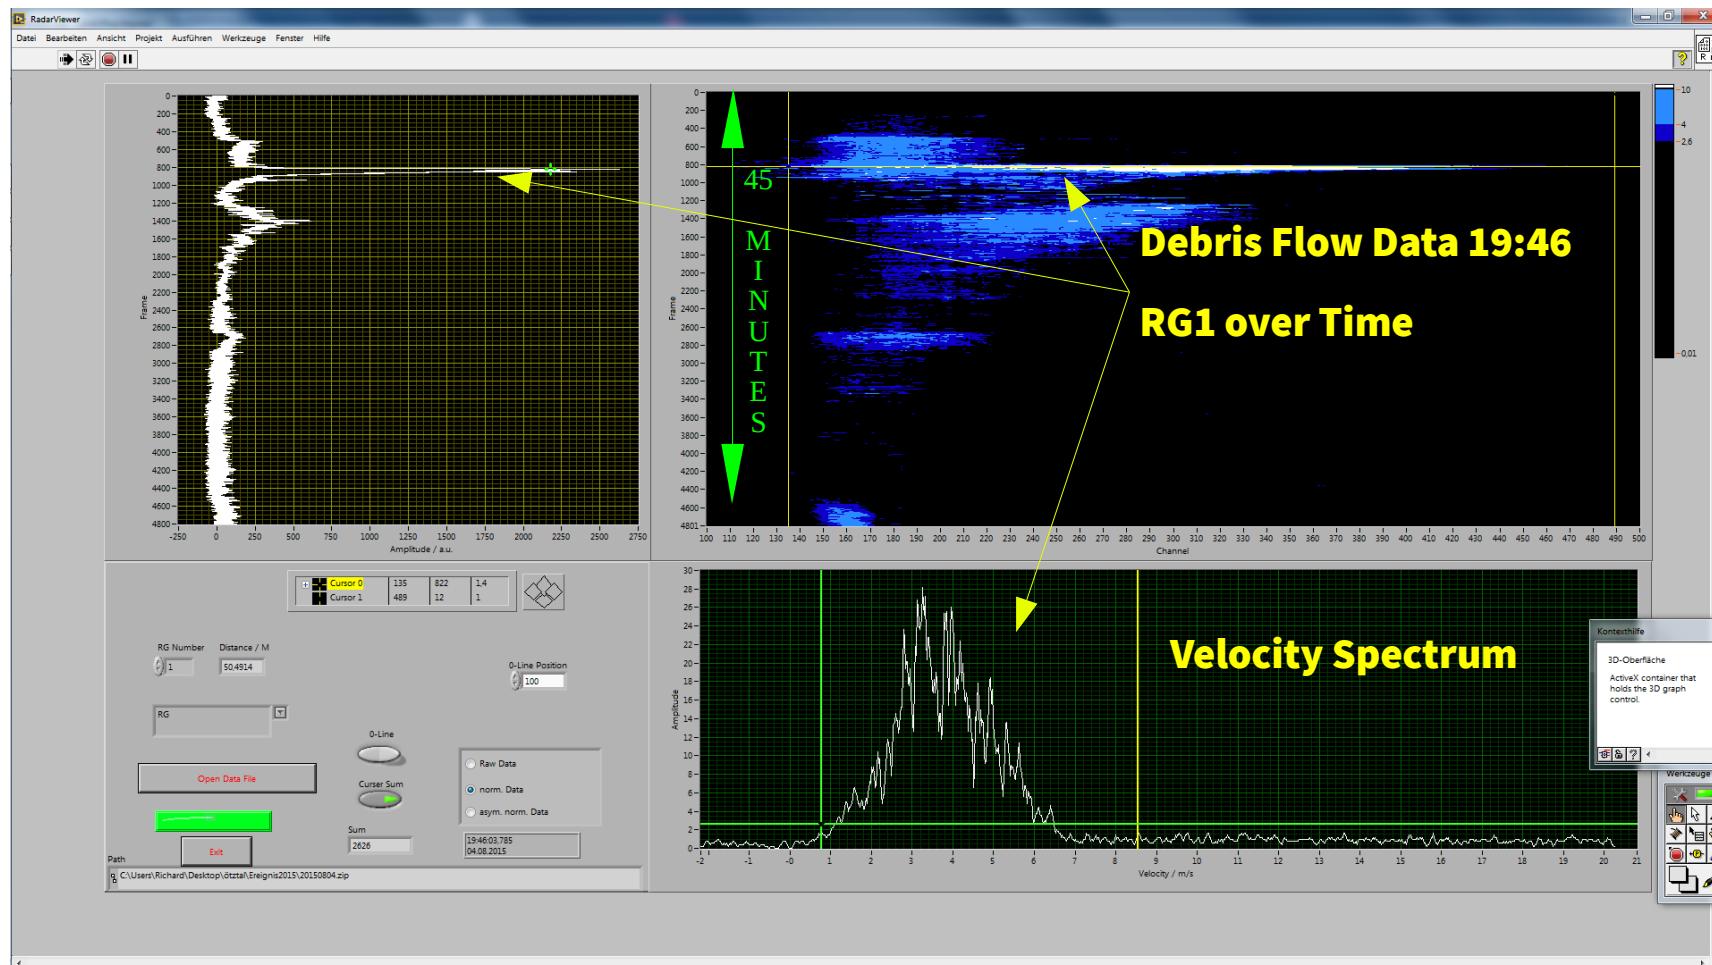
## System Umhausen RG1 04.08.2015
