# Let it be PLANNED!

## Avalanche-, Debris Flow- and Mudslide RADAR

DI Dr. techn. Koschuch Richard

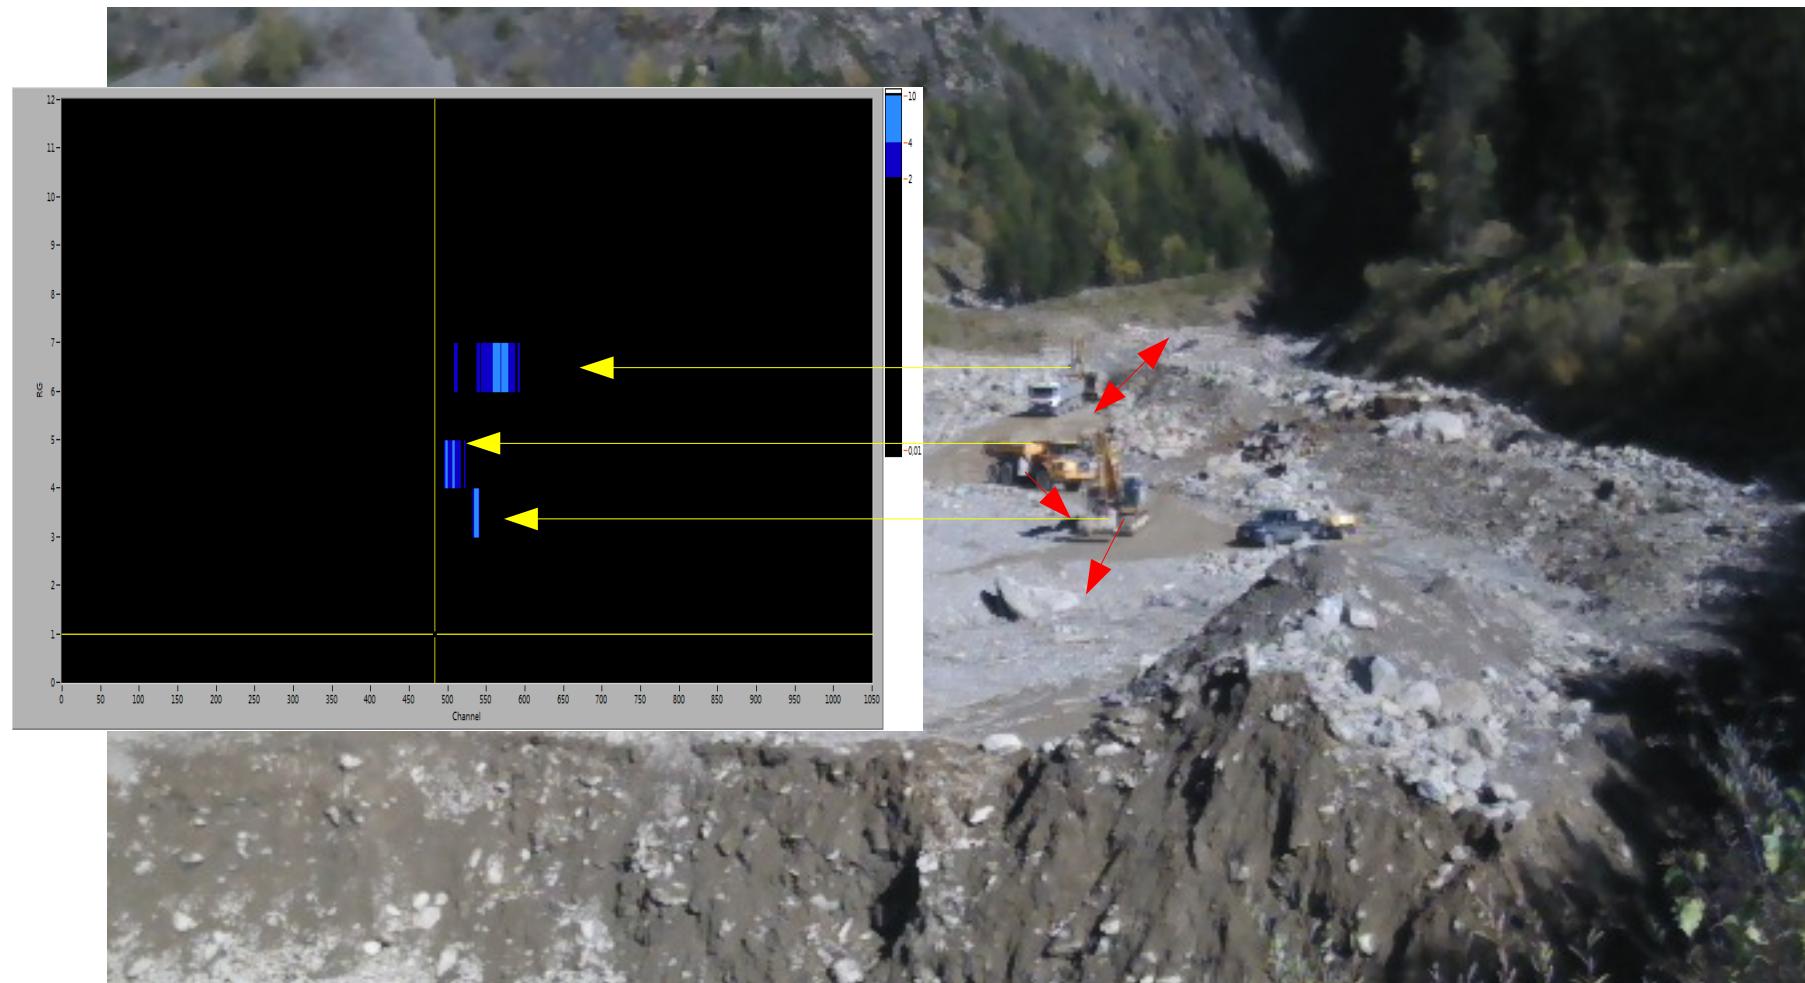
## System Umhausen Moving Objects
